RAILROAD ACCIDENT REPORT

DERAILMENT OF
NEW YORK CITY TRANSIT AUTHORITY
SUBWAY TRAIN
DEKALB AVENUE STATION
BROOKLYN, NEW YORK
MAY 15, 1985

NTSB/RAR-86/01

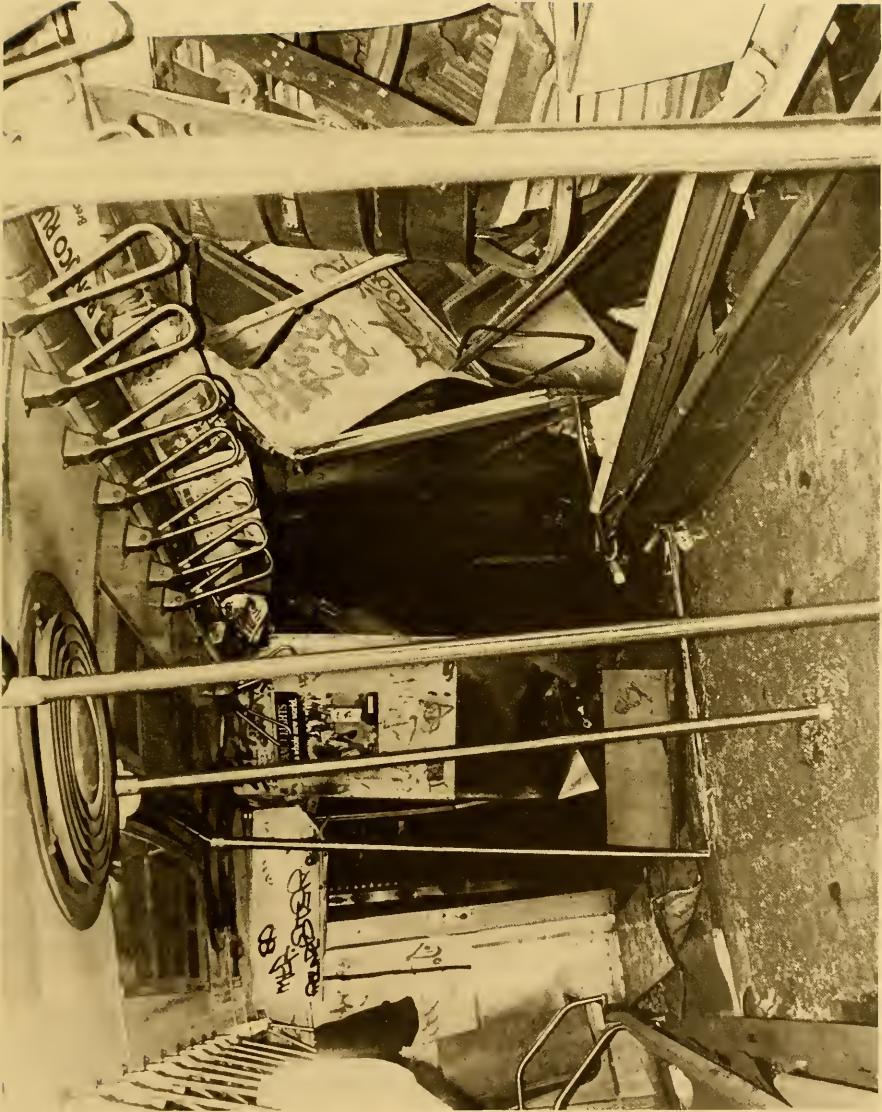
As a result of the impact with the track separation wall, 20 feet of the right sidewall of the derailed second car was torn and wedged between the car and the wall. The right-front corner of the car was crushed, and the roof was buckled 6 inches downward. The floor of the car was buckled 2 feet upward. Seats along the portion of the torn side wall were destroyed. (See figure 3.) Damage to the car was extensive, beyond repair, and estimated at \$350,000. Damage to track and signal equipment was estimated at \$50,000.

Figure 3. --Extensively damaged second car in train.

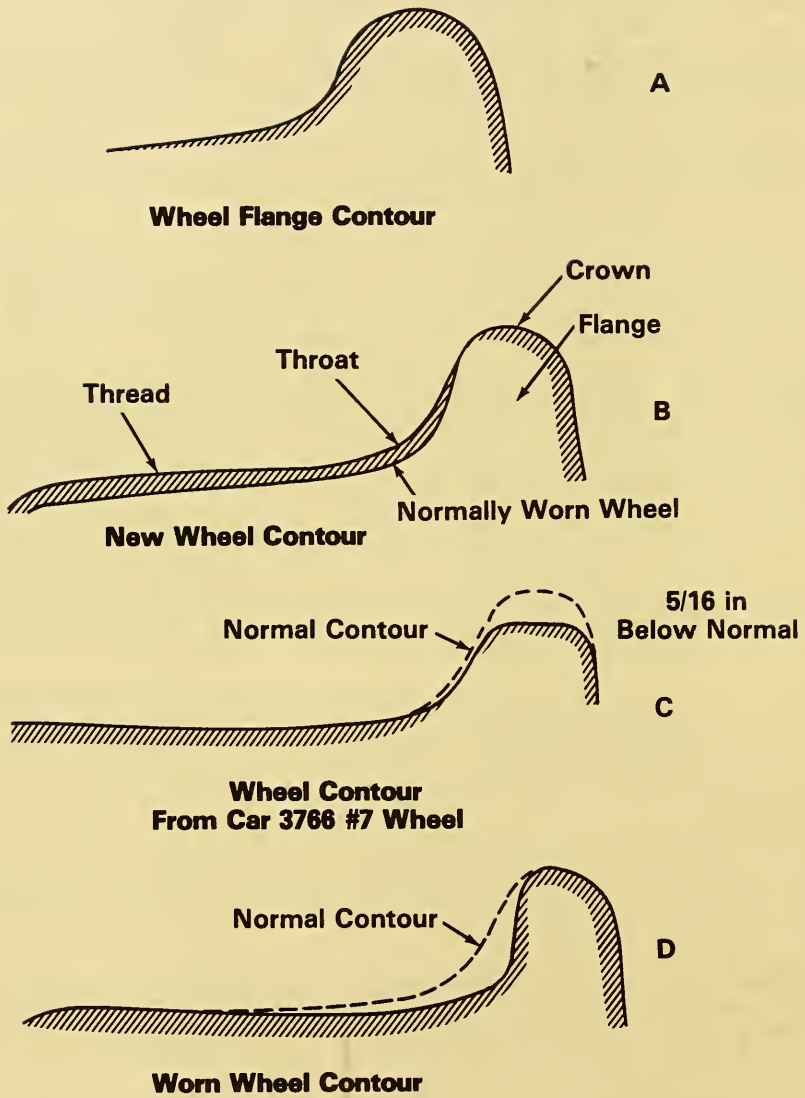
The postaccident inspection disclosed that the wheel flanges on all of the train's car wheels except one were normal. The flange of the No. 7 wheel on the derailed second car (the lead wheel of the second car and the first wheel to derail) was worn to a flat surface that was approximately 1/8 inch lower than the mate wheel on the axle. (See figure 4. Sketch C shows the unusual wheel wear found on the first wheel that derailed in this accident, sketch A shows a new wheel contour, sketch B shows the normal area of wheel wear, and sketch D shows a wheel with normal wear.) The cast-iron brake shoe at the No. 7 wheel location was worn down to the backing plate. The brake rigging, which was holding the brake shoe against the wheel, could not be removed; the brake rigging was dismantled to remove the brake shoe because the rigging was distorted. There was no indication that this condition was caused by the derailment. However, the wheel tolerances were within NYCTA maintenance standards.

Figure 4.--Wheel flange wear on second car.

The No. 7 wheel, the lead wheel on the right side of the second car, had a flat surface on the flange. Thus, it had a greater opportunity to strike and go over the switch point than if it had been more rounded. The amount of wear on the wheel could not have occurred during the derailment but probably occurred over a period of time before the derailment. The brake rigging must have been binding and holding the brake shoe against the wheel as indicated by the brake material being worn off and the steel backing plate contacting the wheel. This steel backing plate in contact with the wheel caused the wearing away of the flange of the wheel and created the flat surface on the flange. This flat surface struck the exposed switch point and went up and over the switch point and derailed. Had the wheel had a more rounded surface, as did the wheels of the first car, it is possible that it would have pushed the switch point against the stock rail and followed the first car into the crossover. However, because of the loose condition of the stock rail, a derailment eventually would have occurred even if the wheel of a car showed no wear.

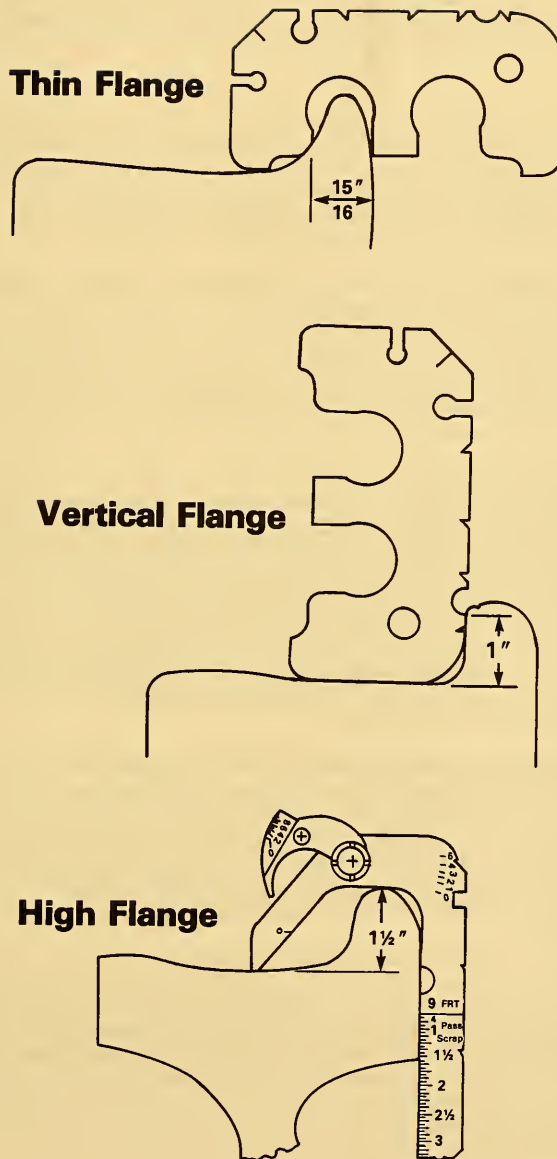
When rail wheels are inspected, the flange of the wheel is checked to determine if, through wear, it is thin, vertical, or high. (See figure 5.) The NYCTA has no minimum height requirements for a wheel flange nor a minimum radius that has to be maintained for it to continue in service.

Figure 5.--Gauging of wheels when inspected.

There are no industry standards to determine the minimum height or the minimum radius to keep wheels in service. This wear problem is limited to those companies that use brake shoes that contact the flange of the wheel. Most rail systems use brake shoes that contact the wheel tread only. Therefore, the NYCTA should establish wear limits for the removal of wheels when the top of the flange becomes worn.

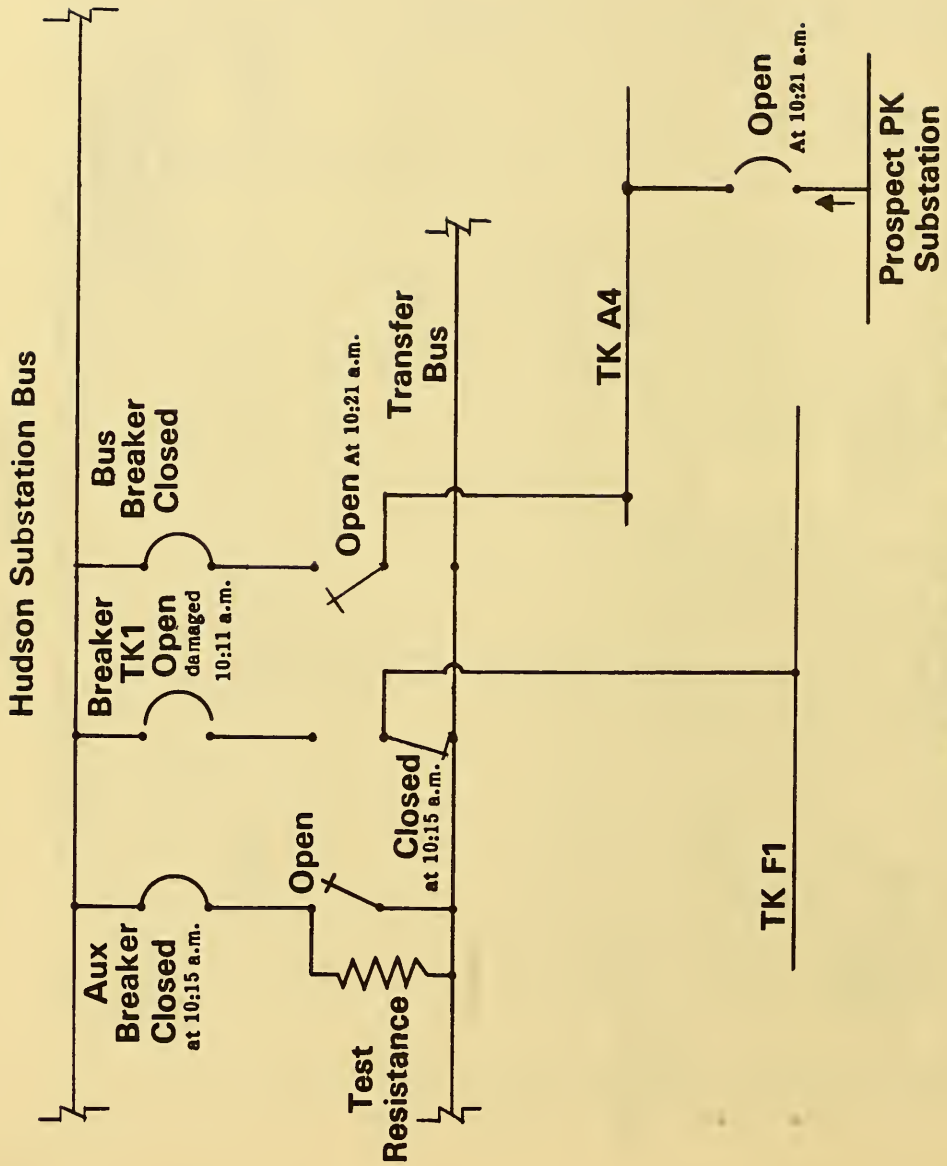
When the train departed the Dekalb Avenue Station About 10:11 a.m.

Figure 8.--Current path.

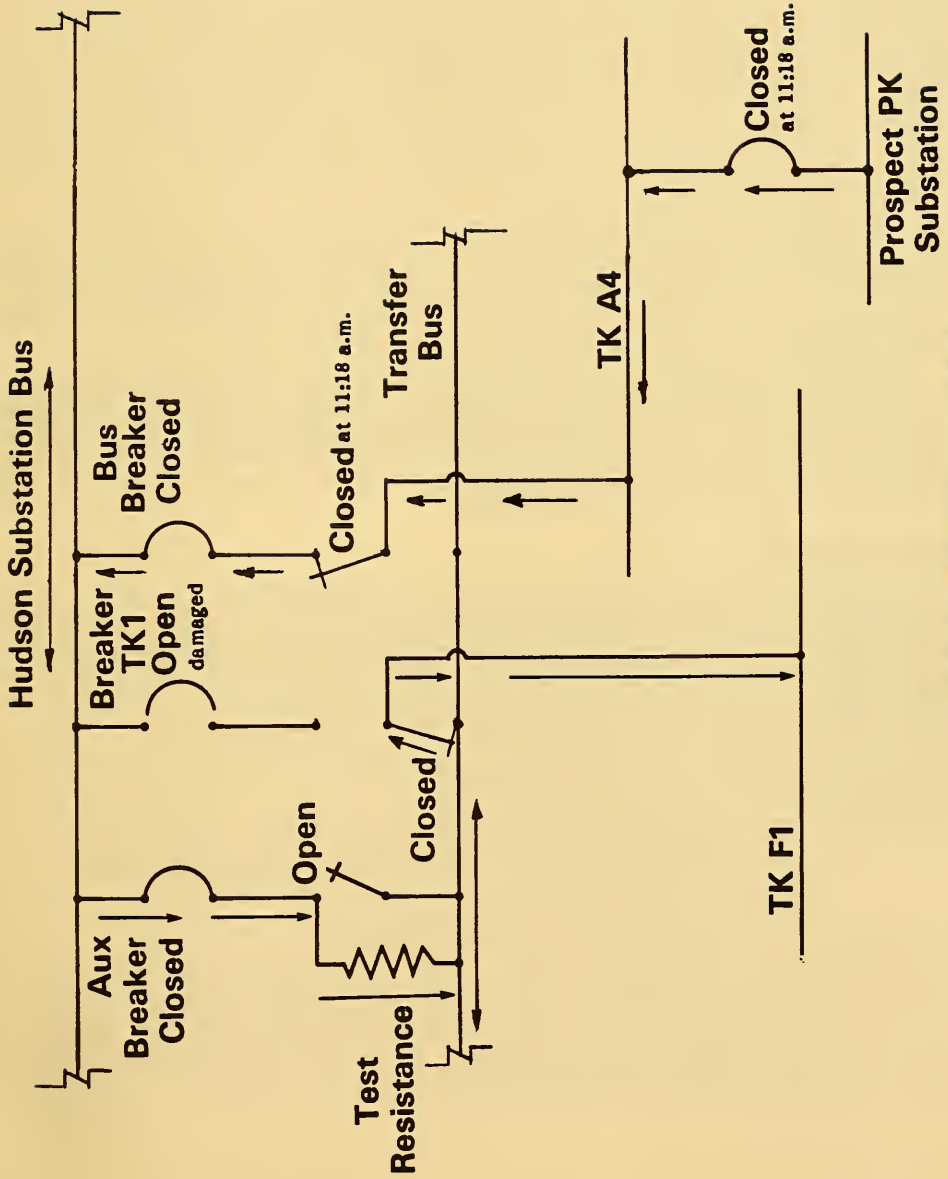
When power maintainer came on duty at 11 a.m.

Figure 9.--Current path.
